Pentium® Pro Processor Specification Update

Release Date: October 1997

Order Number: 242689-021

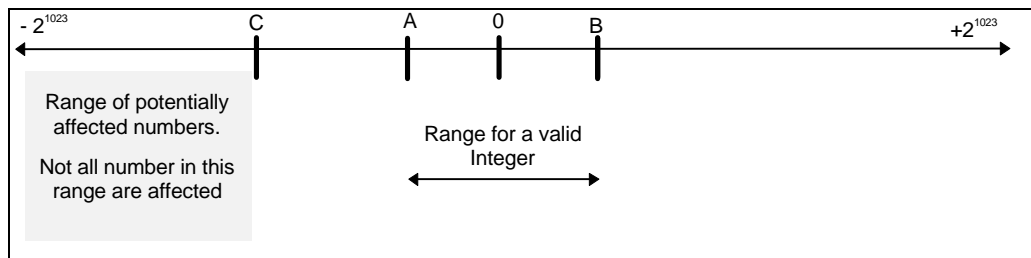
IMPLICATION: Erroneous operation results when the operand is so large that it will not fit into the target data size. The operands affected by this erratum are significantly outside (by a factor of 3X) the range that can be, correctly, converted to an integer value. The figure below and corresponding table identifies the normal range of integer numbers (between A and B) and the starting point of the operands affected by this erratum. Discrete failing operands will be present in the range between point C and the maximum negative number that can be represented by the processor (-2^{1023} in double precision format). Note 2 below gives a qualitative description of the nature of the discrete failing values. Software that does not rely on the Invalid Operation exception flag being set and signaled by either an exception OR by software polling is not impacted by this erratum.

16-bit Operation	A	B	C
	-32,768.0	+32,767.0	< -98304.0
32-bit Operation	A	B	C
	-2,147,483,648.0	+2,147,483,647.0	< -6,442,450,944.0

WORKAROUND: Any of two software workarounds will avoid occurrence of this erratum:
